Contract #: 04-0120F4Cty: SF/ALA Rte: 80 PM: 13.2/13.9File #: 13.28**WELDING INSPECTION REPORT****Resident Engineer:**Pursell, Gary**Address:** 333 Burma Road**City:** Oakland, CA 94607**Report No:** WIR-006334**Date Inspected:** 17-Apr-2009**Project Name:** SAS Superstructure**OSM Arrival Time:** 700**Prime Contractor:** American Bridge/Fluor Enterprises, a JV**OSM Departure Time:** 1530**Contractor:** Oregon Iron Works Clackamas, Or.**Location:** Clackamas, OR**CWI Name:** Mike Gregson, Rob Walters**CWI Present:** Yes No**Inspected CWI report:** Yes No N/A**Rod Oven in Use:** Yes No N/A**Electrode to specification:** Yes No N/A**Weld Procedures Followed:** Yes No N/A**Qualified Welders:** Yes No N/A**Verified Joint Fit-up:** Yes No N/A**Approved Drawings:** Yes No N/A**Approved WPS:** Yes No N/A**Delayed / Cancelled:** Yes No N/A**Bridge No:** 34-0006**Component:** Hinge K Pipe Beams**Summary of Items Observed:**

Hinge-K Pipe Beam Assembly 102A-1: 4/17/09

## WELDING INSPECTION REPORT

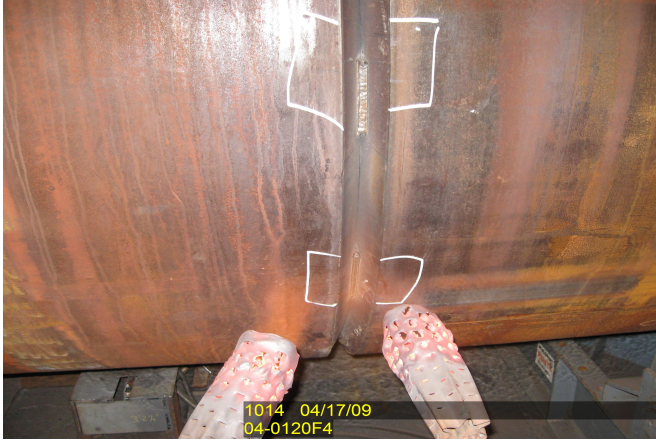
Hinge-K Pipe Beam Fuse Assembly 120A-3: 4/17/09

QA Inspector randomly witnessed welder #S53, Mr. Jerry Shepherd, perform submerged arc welding (SAW) on CJP (AWS D1.5 B-U3c-S), half fuse pipe assembly, (piece mark identified as a124-12), to half fuse pipe assembly, (piece mark identified as a124-10), in the flat position (1G).

QA Inspector noticed Mr. Mike Gregson and QC Inspector Rob Walters were present and monitoring in-process welding parameters (amps/volts) and pre-heat temperatures, verifying Mr. Jerry Shepherd was in compliance with the applicable welding procedure specification (WPS 4020).

QA Inspector verified Mr. Jerry Shepherd was currently qualified for this welding process/position and performed a random pre-heat check and recorded temperatures of approximately 350 degrees Fahrenheit, which is in compliance with the OIW welding procedure specification (WPS 4020). See attached picture below.....
